Emergency Spillway Work Area 1 DWR the Emergency

continues to reinforce Spillway and reestablish access roads. with construction crews working around the clock.

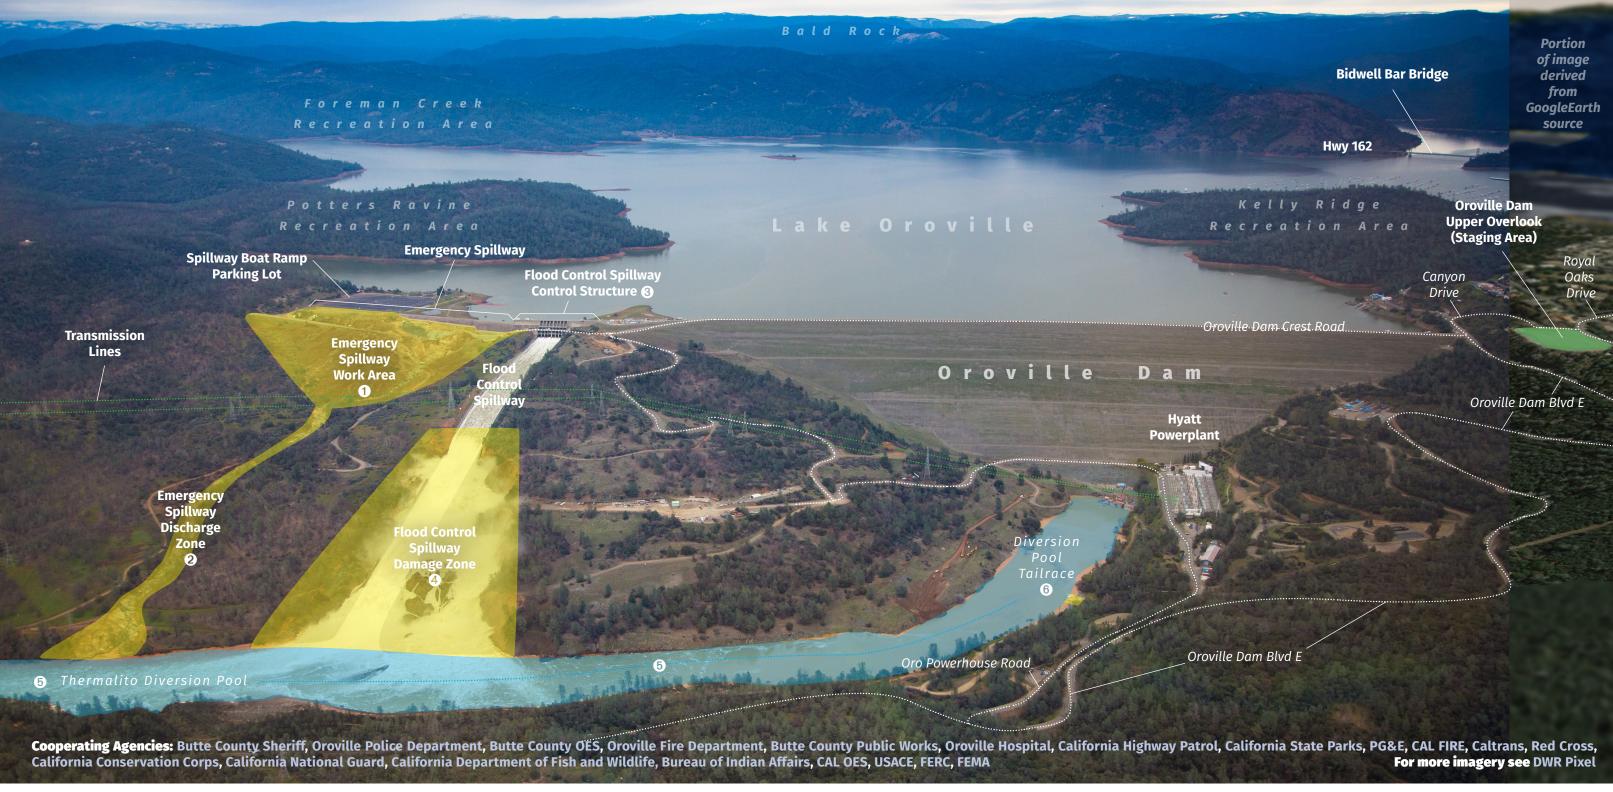
Emergency Spillway Discharge Zone 2 This area has been inspected and continues to be monitored for any erosion. Transmission lines have been inspected and function normally.

Flood Control Spillway Control Structure 3 Monitoring

of structure continues. Operations are normal.

Flood Control Spillway Damage Zone 4

Assessment of structure continues as flows are reduced. Plans to maintain and repair the structure will be presented as they develop.

Thermalito Diversion Pool to Hyatt Powerplant

5 Erosion debris to be removed in order to begin operations at Hyatt Powerplant as soon as practical.

Hyatt Powerplant/ Diversion Pool Tailrace 6

Reducing the water surface elevation of the tailrace will be accomplished through the downstream debris removal process, thus allowing for Hyatt Powerplant startup.
